**Jane Doe**

**1544 Lark Lane SE, Kentwood, MI**

**Date: 3-3-2019**

**Type of Structure: 1.5 Story; 3 bed, 2 bath**

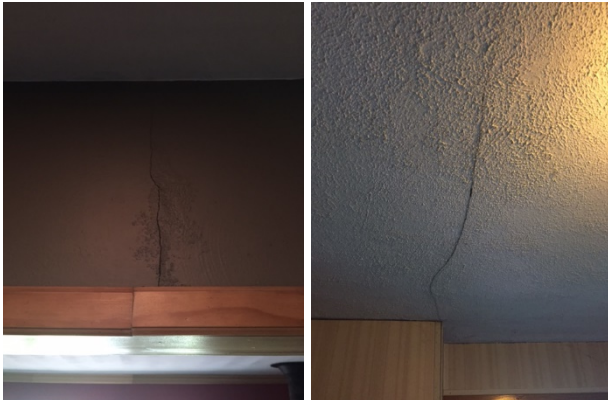
There were several signs of settling or shifting that had caused cracking in walls and ceiling throughout the home at the time of the inspection. There were no major foundation cracks or damages noted that would indicate structural issues beyond natural settling over time.

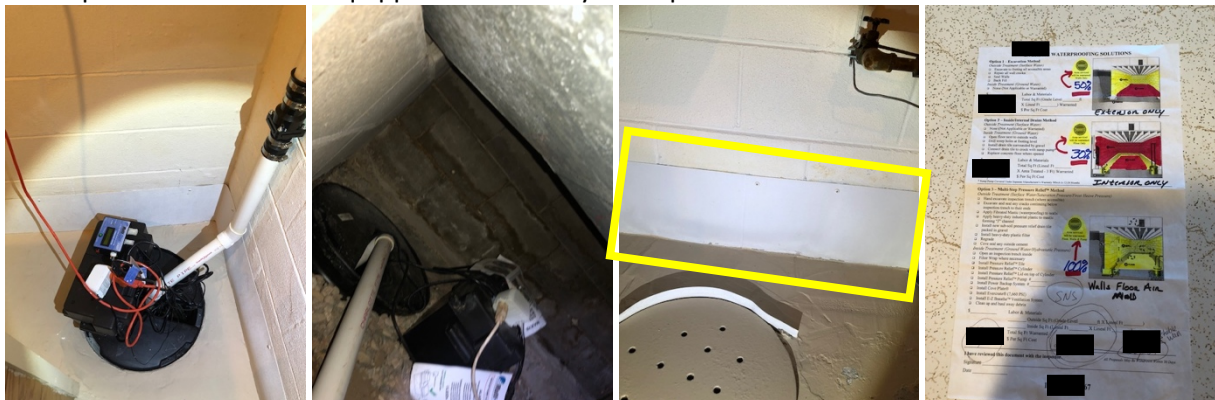
The home had a waterproofing system installed around the perimeter on the interior basement walls at the time of the inspection. This type of system works to contain the water leaking through walls of the home and drain it all to the installed sump pumps. There was a sump pump installed in the basement laundry room and crawlspace and both were equipped with battery backups.

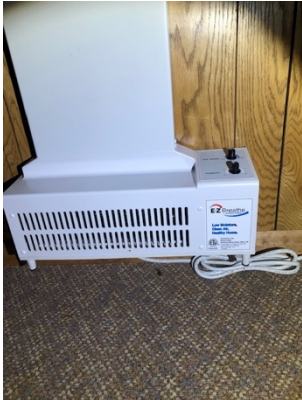
There was a basement dehumidifier system installed in the home (these are generally installed with waterproofing systems) at the time of the inspection that was functioning properly.

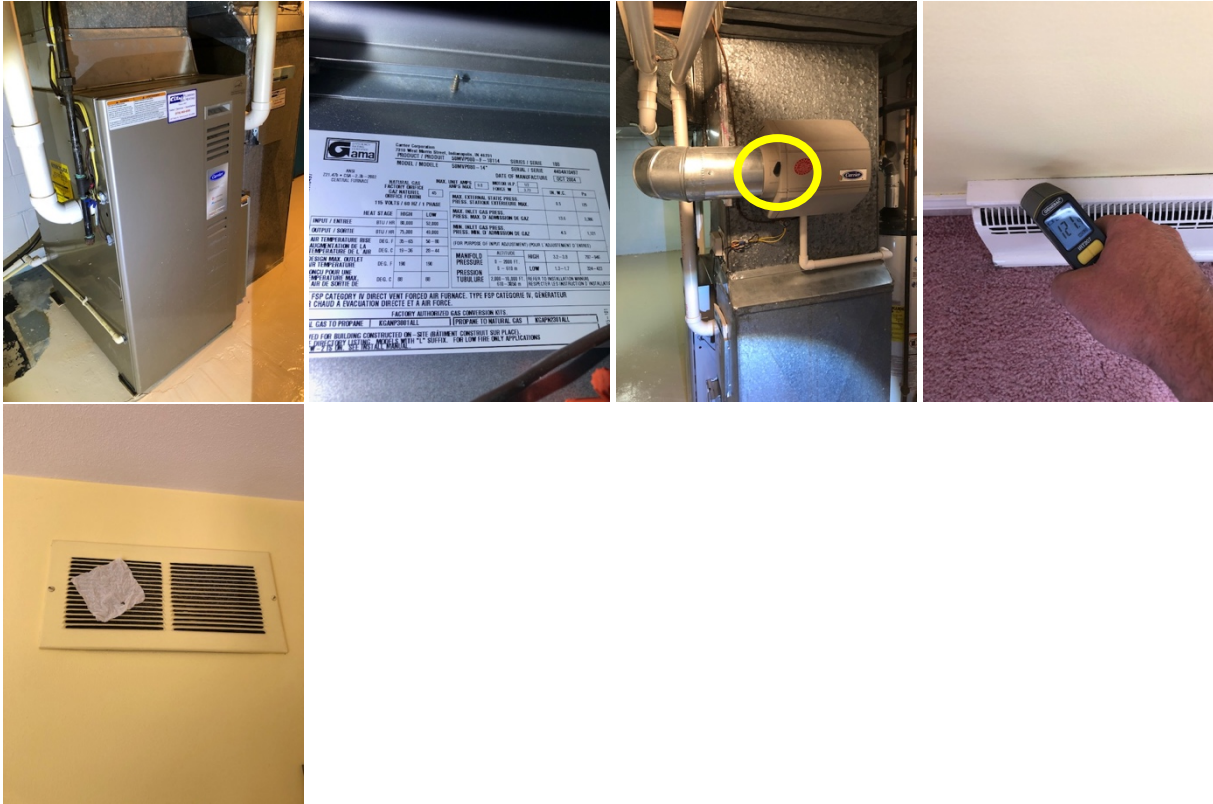
## Humidifier ON/OFF damper

The furnace fired when activated by the thermostat at the time of the inspection and produced sufficient heat at tested registers throughout the home (Normal expected range is between 110-120+ degrees Fahrenheit at registers). Return air was pulling sufficient air back to the furnace (holding tissue paper against vent). The unit appeared to be installed in 2004 based on the serial number (typical average lifespan is 20-25 years). Note that disposable filters this size should be changed every 2-3 months during peak usage seasons (summer cooling & winter heating). A clogged or backwards filter will decrease the efficiency of the furnace and make the unit work harder as air flow is being restricted. A whole house humidifier damper needs to be closed (OFF) every summer and opened (ON) every winter with the humidistat on the ductwork being adjusted to the desired humidity setting. We suggest regular service/preventative maintenance by a licensed HVAC contractor to help prolong the life and efficiency of the unit. Generally, the best time for service is right before start-up as the temperature drops in the Fall.

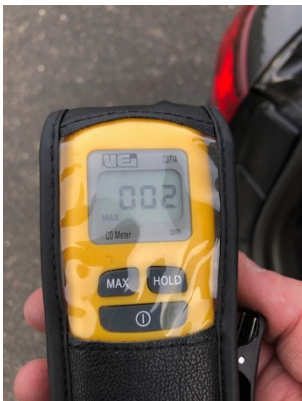
The maximum monitored carbon monoxide (CO) measured for the duration of the inspection was 2ppm (parts per million). Max allowable for short-term exposure is 9ppm (see chart below).

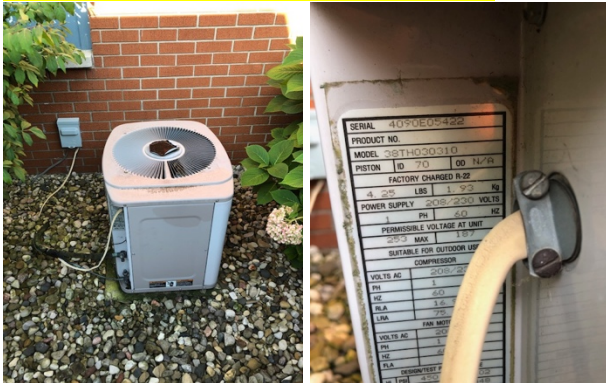
The A/C functioned properly when tested at the time of the inspection and produced sufficient cool air at tested registers throughout the home (Normal expected range is between 45-55 degrees Fahrenheit at registers). There was no visible damage to the exterior condenser unit or interior A-coil noted. We do recommend covering the exterior condenser as much as possible in the fall and winter months to protect against debris collecting inside and falling ice from the roof that can damage the unit. We suggest regular service/preventative maintenance by a licensed HVAC contractor to help prolong the life and efficiency of the unit. Generally, the best time for service is right before start-up in the Spring. The A/C system was approximately 29 (1990) years old. **The A/C system should be considered a potential service, repair, or replacement item within the next 5 years** (typical average lifespan is 15-20 years).

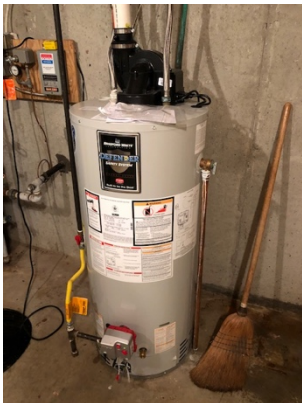
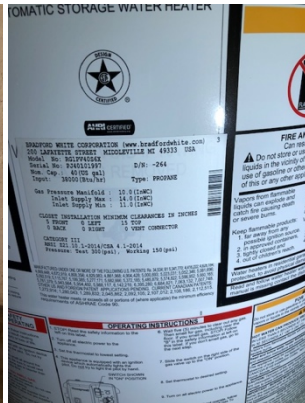
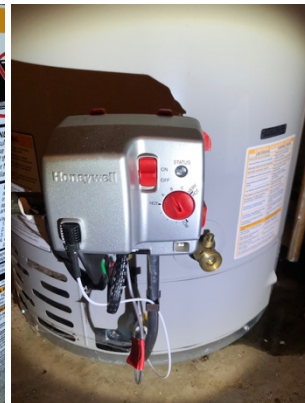
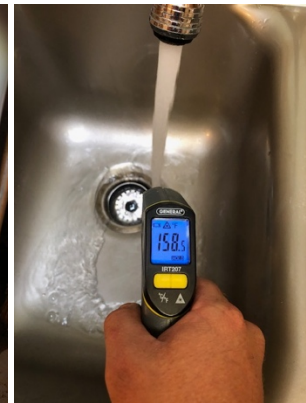
The water heater produced excessive hot water at tested faucets the time of the inspection (Expected range is 110-120 degrees Fahrenheit). Water temperatures were exceeding 150 degrees, which can cause third degree burns to skin in as little as 2 seconds. Temperatures can be adjusted at the unit. The water heater was approximately 2 years old based on the serial number.

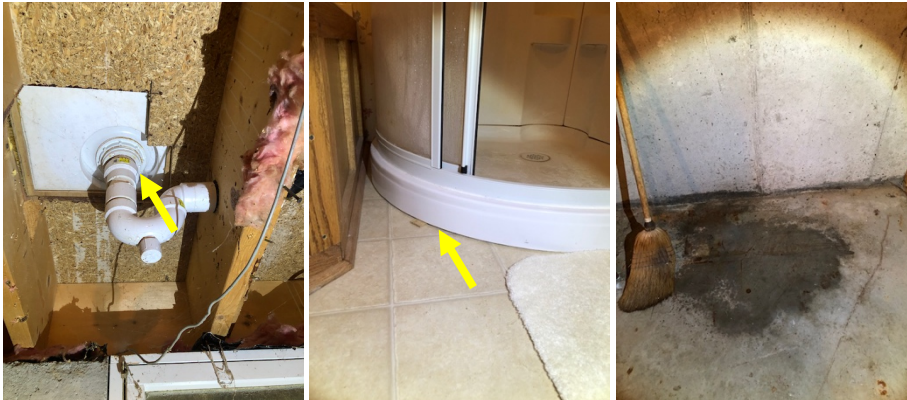
There were plumbing drain and supply line leaks noted from the basement at the time of the inspection. There were also slow drains noted due to improperly run drain line slope. We recommend contacting a licensed plumber to correct these issues and repair any leaking pipes.

Stall shower in master bathroom: Leaking drain connection and shimmed up off the floor

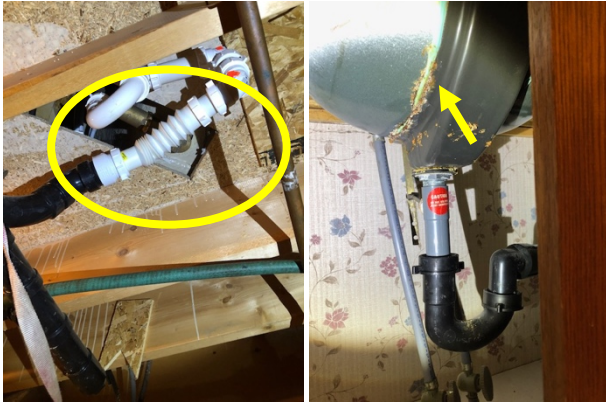
Master bathroom sink: Flex connection to main plumbing should be replaced with hard pipe. Leaking joints. Sink overflow line showing signs of leaking.

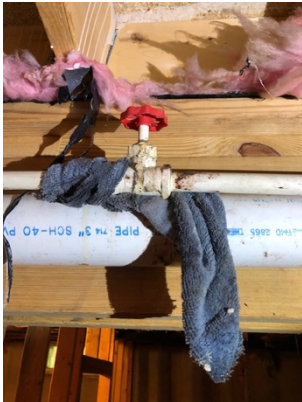
Supply line valve: leaking

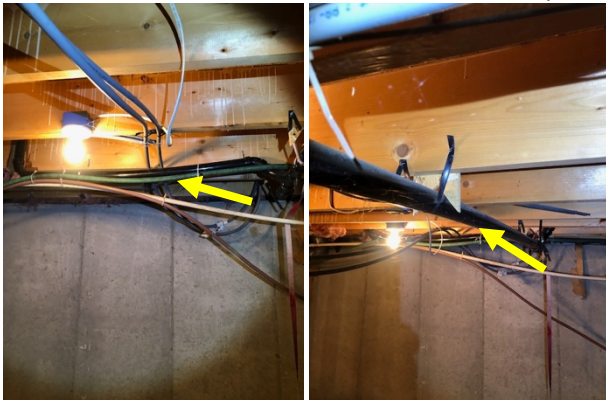
Slow drain in master bathroom sink and whirlpool due to incorrect drain slope:

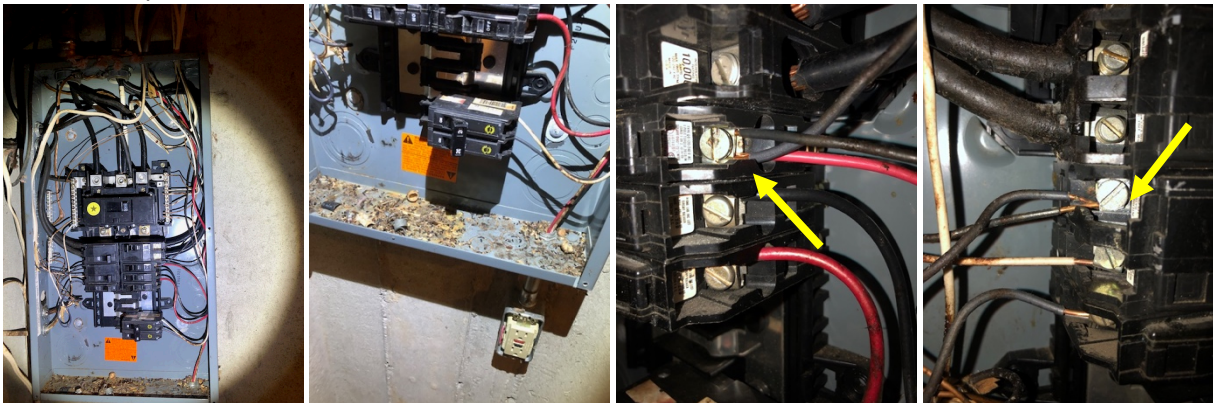
There were two multi-tap breakers (double and triple tapped) in the main panel in the basement at the time of the inspection. These types of breakers are designed to hold two copper wires at the same time, but even the double-tapped breaker was wired incorrectly for the breaker type. We recommend having these circuits separated to individual breakers in the panel. There were also signs of mice droppings and nesting in the main panel

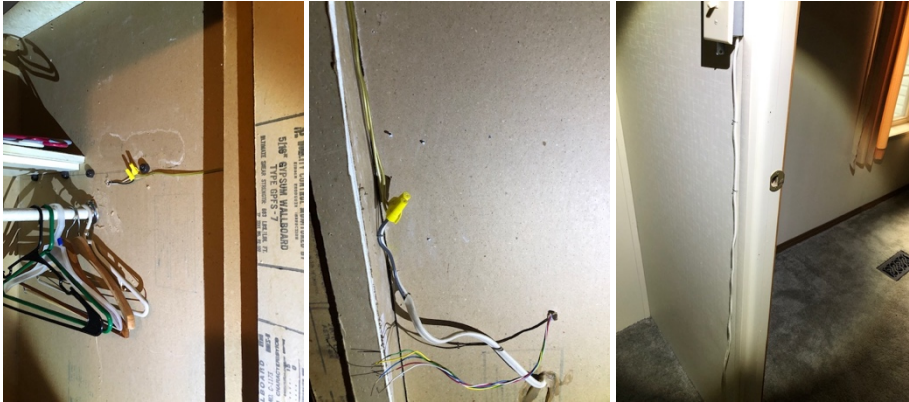
Exposed wiring in bedroom closets: Junction boxes and conduit required

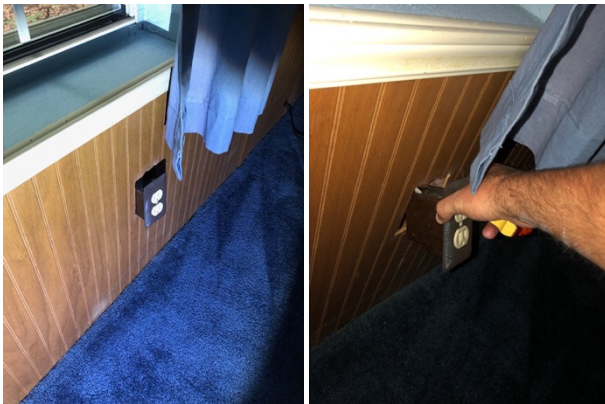
Loose outlets on walls:

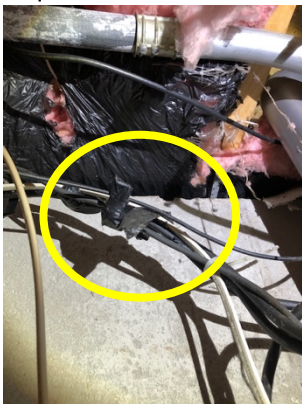
Taped clumps of wiring next to main electrical panel: Proper junction boxes and wiring connections required.

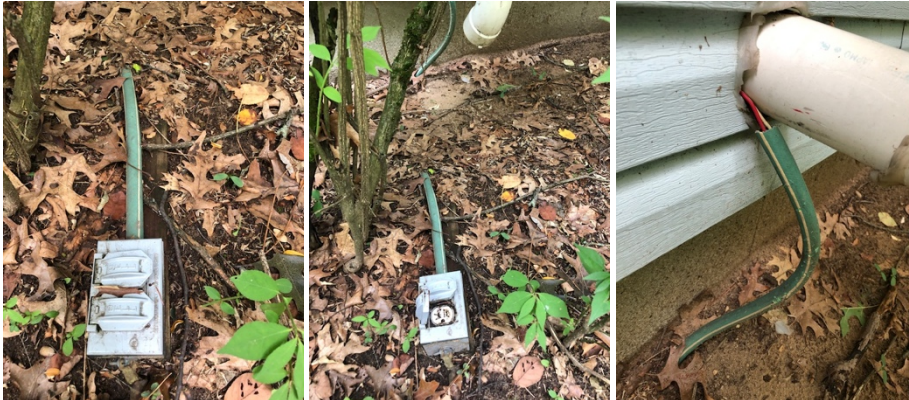
Garden hose used as exterior conduit: Proper conduit materials, mounting off the ground, and GFCI outlet required.

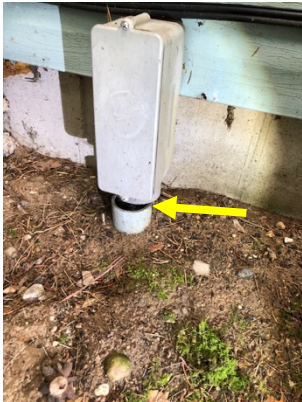
Conduit junction elbow box disconnected at house: Secure connection required to keep water out.

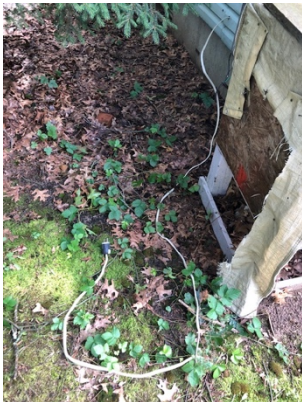
Generator wire from main panel left exposed on the ground on the exterior of the home.

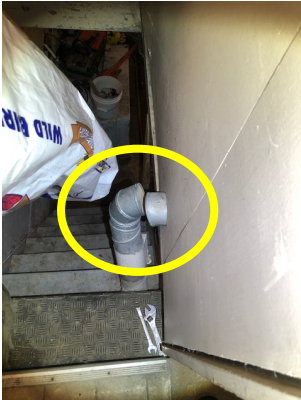
The dryer could not be tested as the dryer vent was broken in the stairwell – this should be repaired before use.

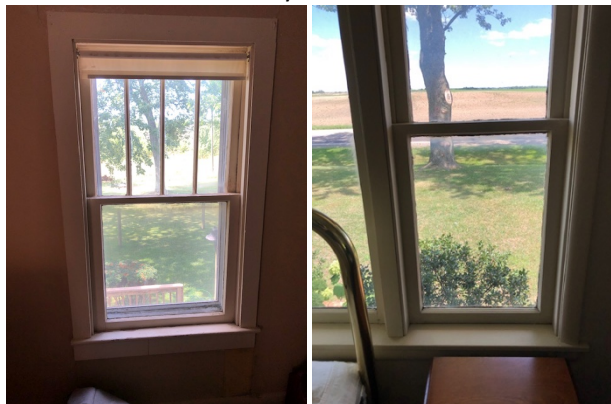
Most windows in the home were older, wood framed windows with single pane glass – these will work fine, but the home's efficiency will suffer. All windows appeared in functional condition although some had been painted shut. Consider updating the home's windows or adding storm windows to the exterior for better insulation and efficiency.

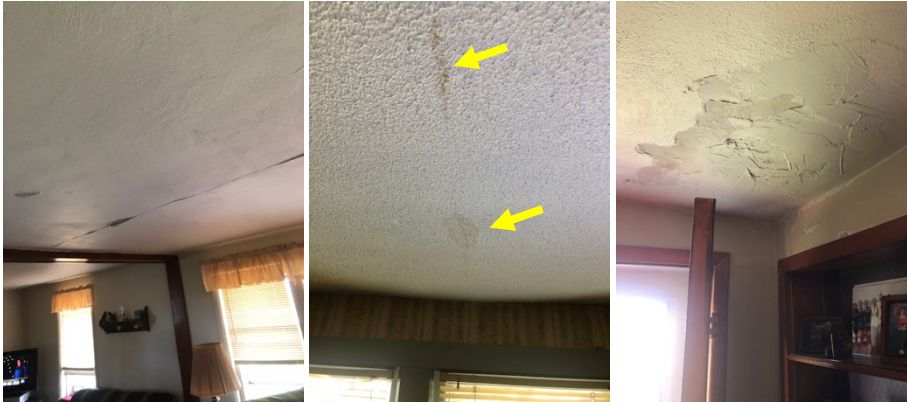
There were multiple ceiling cracks noted throughout the home at the time of the inspection. All material seemed to be secured solidly in place and cracks were likely coming from the home's settling and age. There were water stains noted on the upstairs east bedroom ceiling, but this appeared to be past staining.

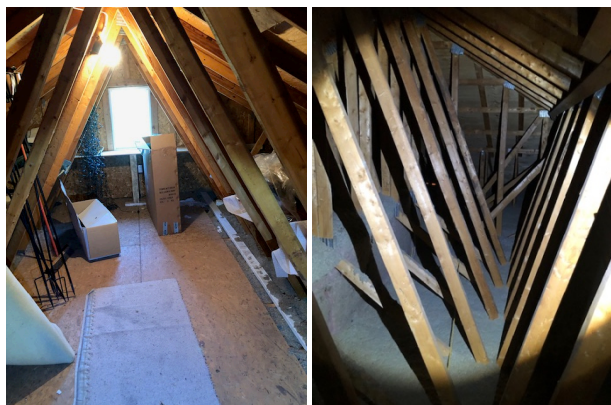
Floored area: flooring material is thin; use caution when walking through this area as floor bows between trusses.

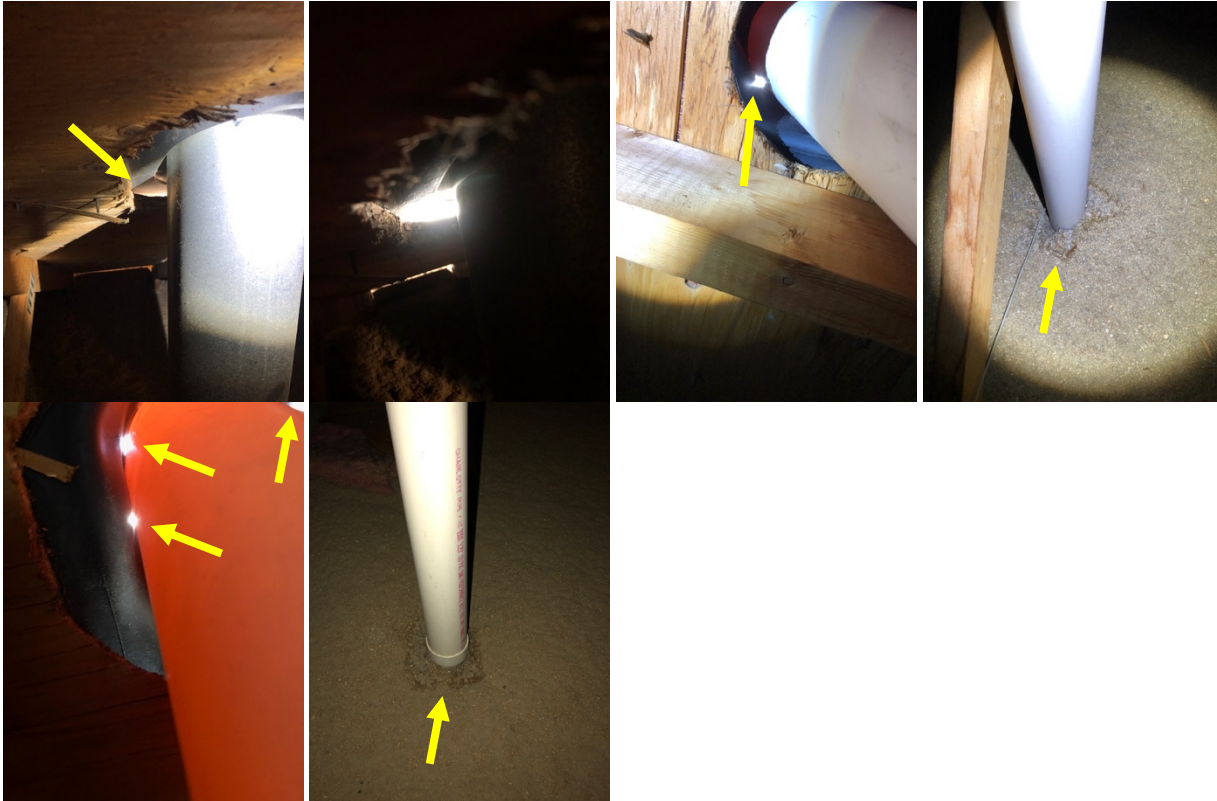
Below PVC plumbing vents:

The attic space showed signs of current leaking at the time of the inspection. There were areas noted from walking the roof that were potential leak points and most had areas of wet insulation noted below in the attic. Leaking at most spots appeared to be fairly minor, but any roof leak should be corrected. We recommend contacting a roofing contractor to replace roof boots around all plumbing vents and metal chimney stacks as well as seal any damaged areas or exposed nail heads.

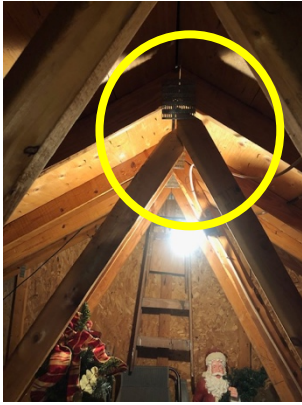
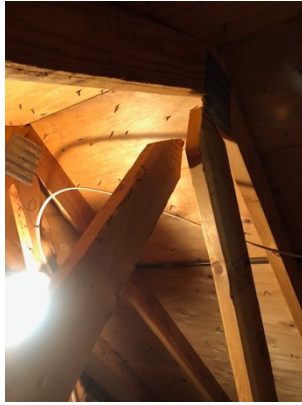
There was a damaged truss connection at the roof peak near top of the pulldown stairs to the attic. We recommend securing the peak point and adding a collar tie for additional support (general concept pictured below for collar tie). This is likely the truss that gets used as a support handle/railing when climbing into the attic storage space.

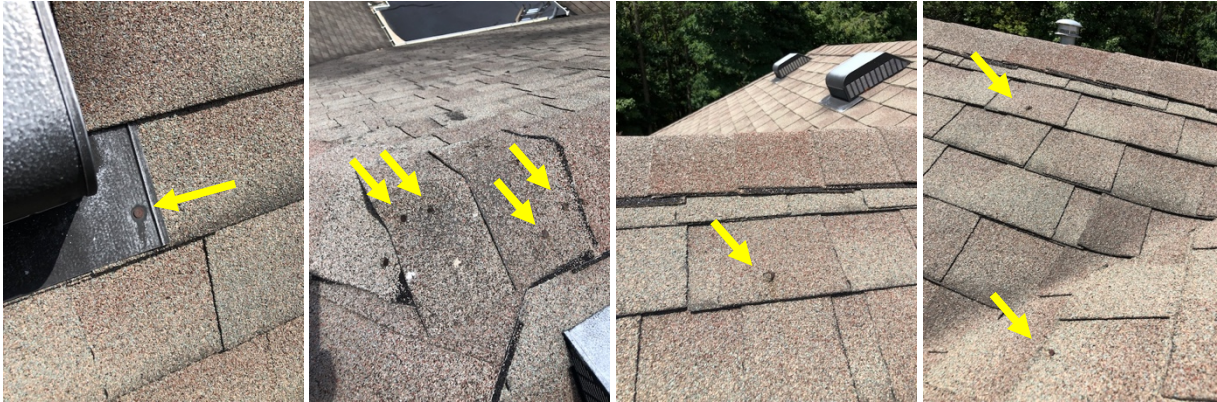
The roof of the home appeared to be original to the home's construction in ~1995. The architectural shingles were still in fair condition, but age and wear were showing on many of the roof boots and vents. The rubber boots were cracking and curling and allowing gaps from the roof and covered pipes. There were many exposed nails (some were likely covered at one point) around the roof that had rusted and will be potential leak points – these should be covered over with a dab or tar or caulk. There were multiple tree limbs that should be trimmed back off of the roof surface. We recommend contacting a roofing contractor to replace roof boots around all plumbing vents and metal chimney stacks as well as seal any damaged areas or exposed nail heads. Any water damaged roof decking should be replaced, and wet insulation should be removed from the attic space.

Exposed, rusting nailing:

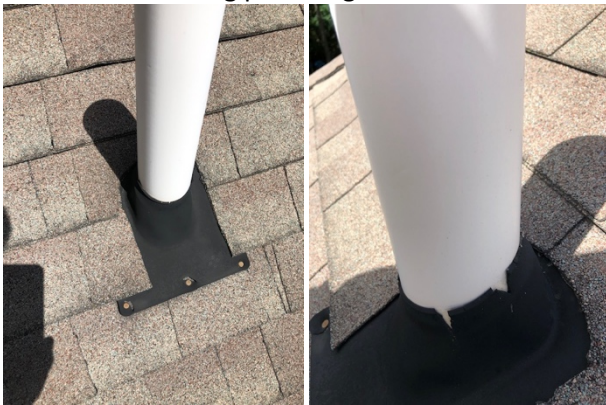
Cracked and curling plumbing vent boots:

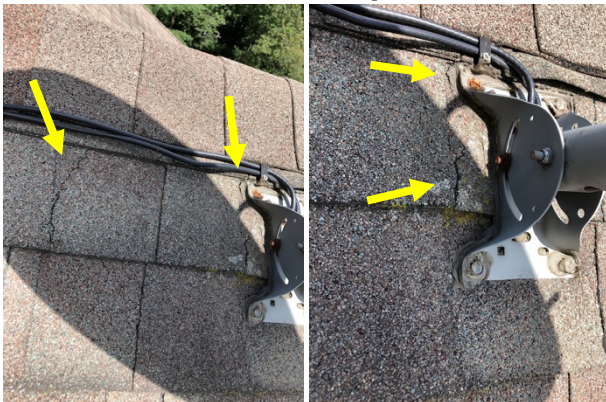
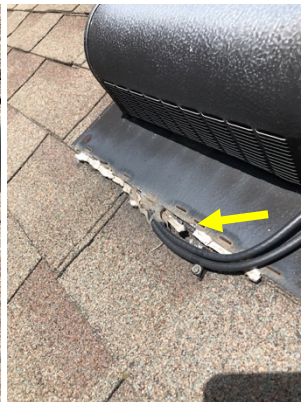
Satellite dish installation damage:

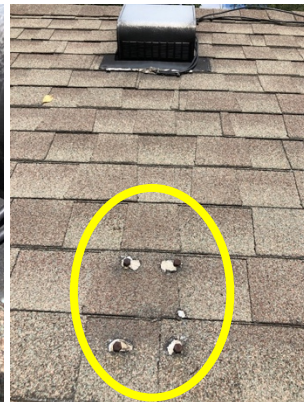
Old dish mount?:

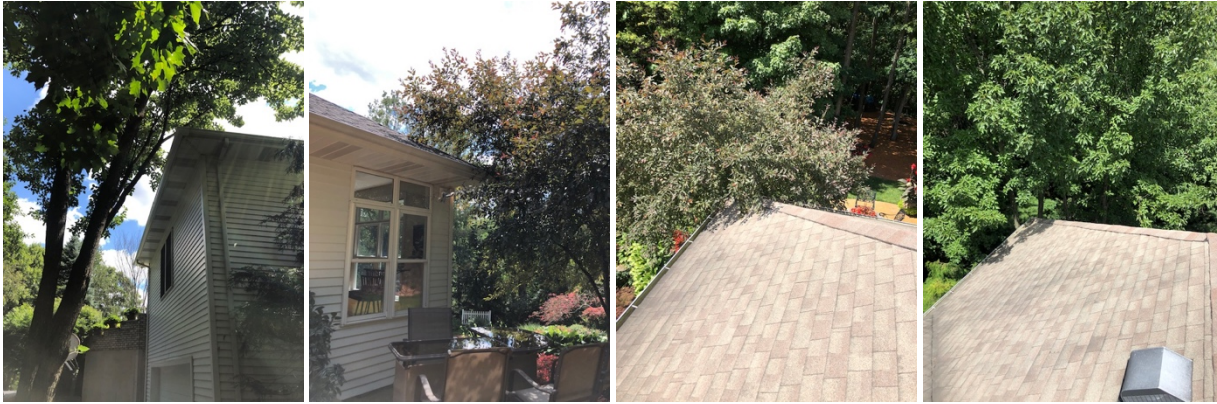
Tree limbs growing in contact with roof shingles:

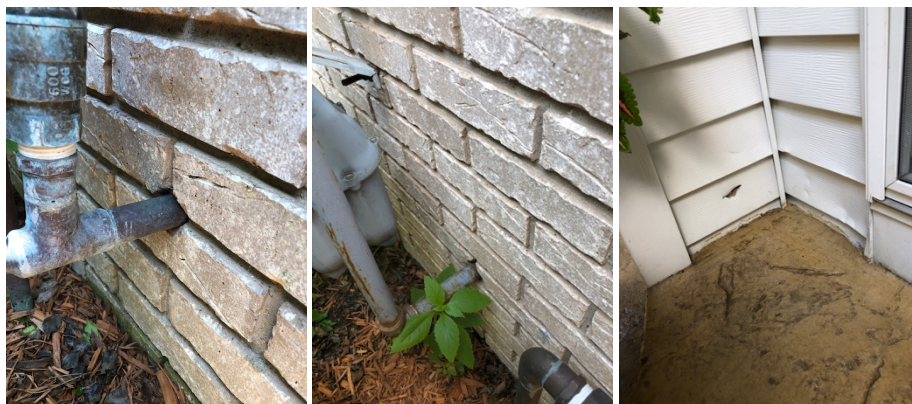
There were wall penetrations and a few minor areas of siding damage around the home that should be sealed from the exterior.

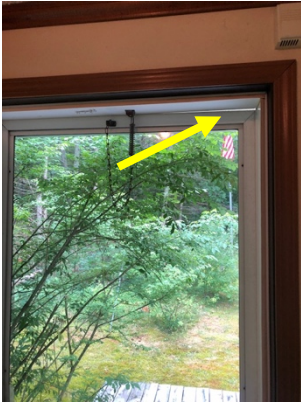
The storm door on the front of the home was misaligned and not sealing properly.

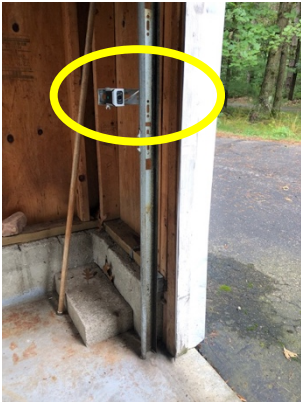
The attached garage door safety sensors were mounted too high to work as designed. These sensor eyes are generally required to be installed 6-8 inches from the ground to be effective.

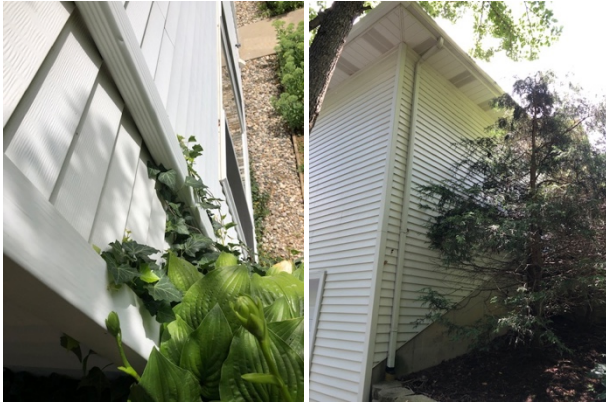
There were trees, vines and shrubbery growing against the exterior wall covering and roof. We recommend keeping all vegetation trimmed back from the home to prevent possible damage to these materials.

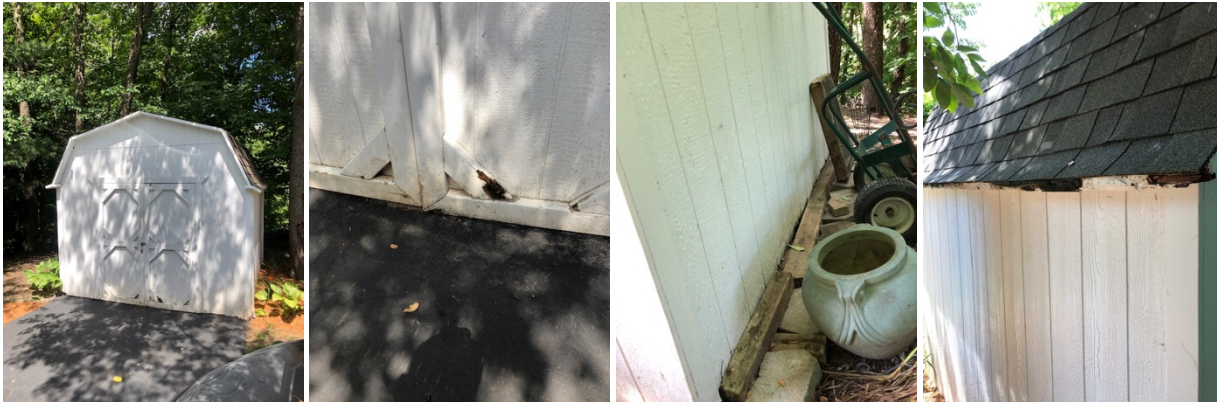
The shed was showing signs of deterioration around the wood exterior. We recommend keeping ground cover off of the wood covering. Keep exterior wood painted or sealed to prevent weathering and rot.

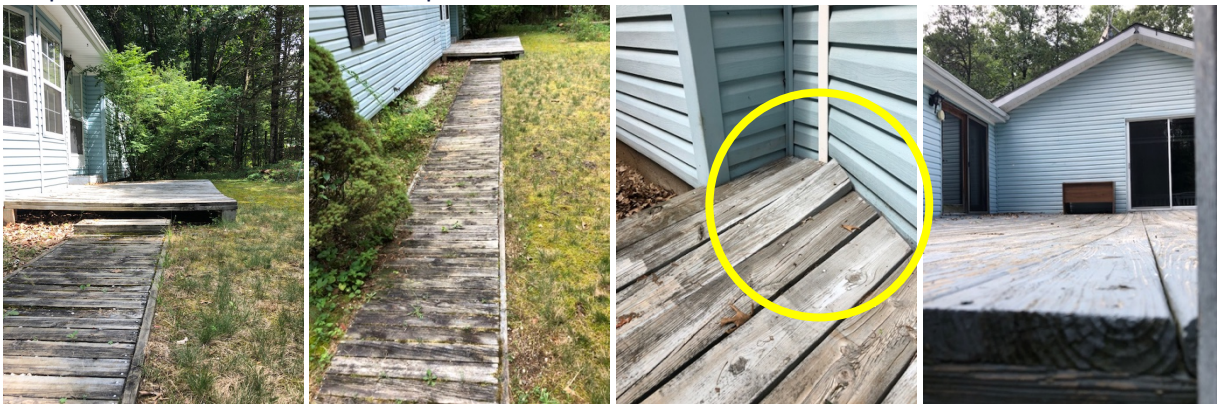
The wood decks on the front and rear of the home were in need of stain or sealant at the time of the inspection. We recommend keeping all exterior wood painted, stained, or sealed to prevent wood rot and deterioration and improve the lifespan of the materials. Both decks were also significantly bowed and warped and in need of structural repair.
