**Jane Doe**

**1544 Lark Lane SE, Kentwood, MI**

**Date: 3-3-2019**

**Type of Structure: 1.5 Story; 3 bed, 2 bath**

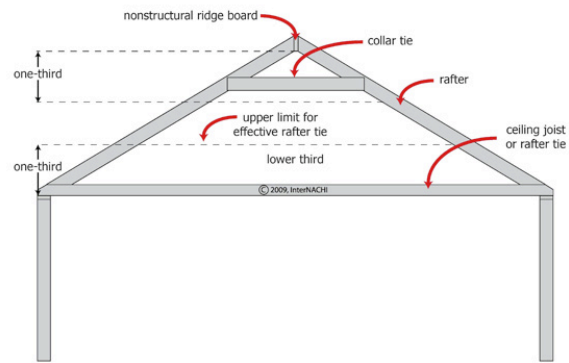
There was a damaged truss connection at the roof peak near top of the pulldown stairs to the attic. We recommend securing the peak point and adding a collar tie for additional support (general concept pictured below for collar tie). This is likely the truss that gets used as a support handle/railing when climbing into the attic storage space.

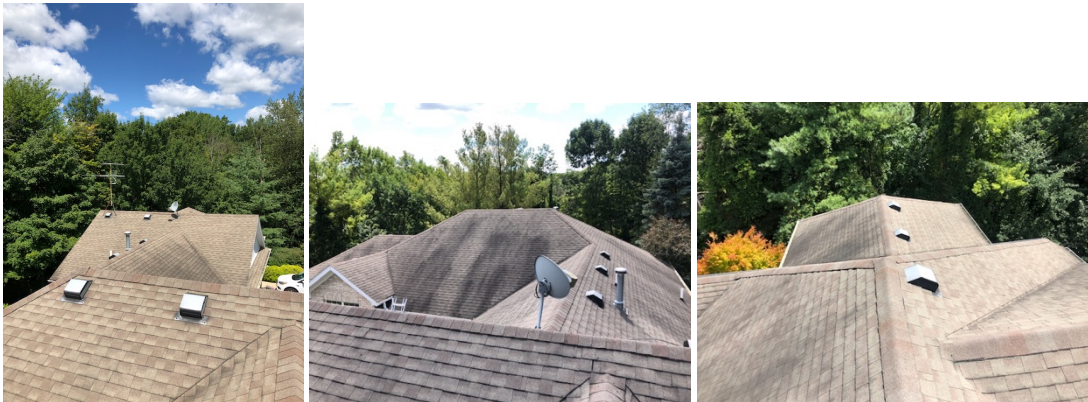
### Overview:

The roof of the home appeared to be original to the home's construction in ~1995. The architectural shingles were still in fair condition, but age and wear were showing on many of the roof boots and vents. The rubber boots were cracking and curling and allowing gaps from the roof and covered pipes. There were many exposed nails (some were likely covered at one point) around the roof that had rusted and will be potential leak points – these should be covered over with a dab or tar or caulk. There were multiple tree limbs that should be trimmed back off of the roof surface. We recommend contacting a roofing contractor to replace roof boots around all plumbing vents and metal chimney stacks as well as seal any damaged areas or exposed nail heads. Any water damaged roof decking should be replaced, and wet insulation should be removed from the attic space.
